*THE SECOND EUROPEAN CONFERENCE ON TUNNEL RENOVATION*

SIG SESSION: INSPECTION, INVESTIGATION AND  
MONITORING DURING SERVICE LIFE

**Damages on lining induced by the construction of a new tunnel  
and the design of refurbishment: a case history**

Motor way **E78 Grosseto-Siena** modernization works: construction of the new **Casal di Pari tunnel** close to the existing/old one

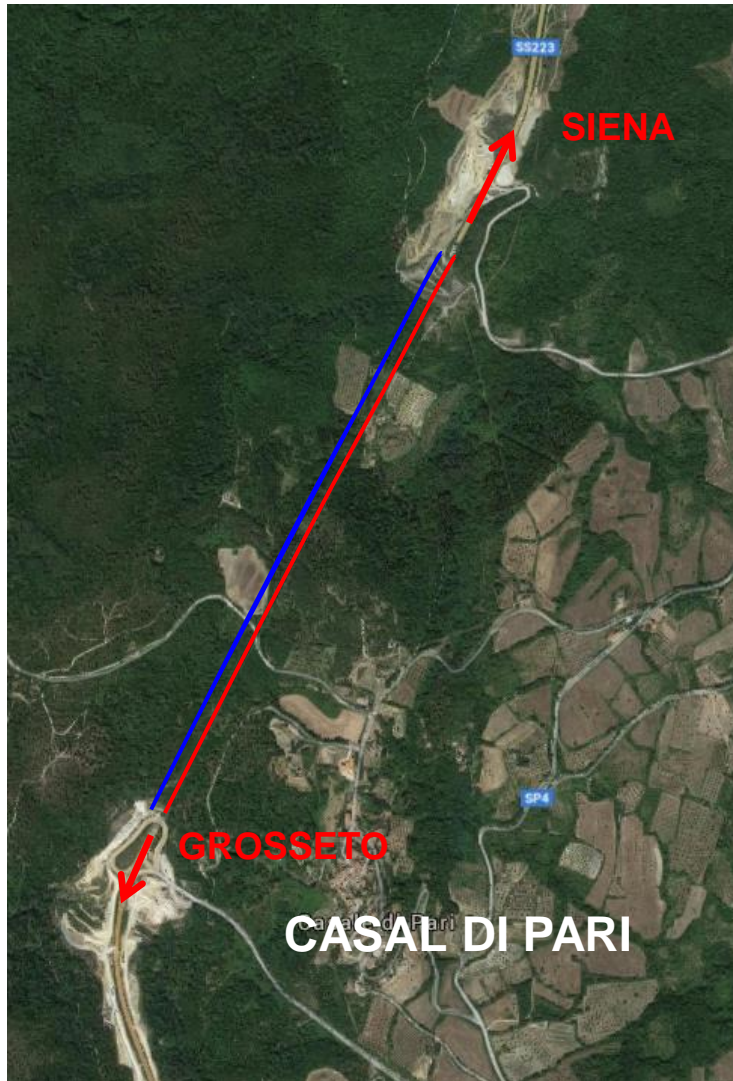
# The two Casal di Pari tunnels

## EXISTING TUNNEL

Gabarit 4.65 m (two tracks)

Excavation Technique: conventional partialized face

Pre-support: metallic ribs and spritz beton

Final lining: plane concrete and locally (masonry)

Lining thickness: 50-120 cm

## NEW TUNNEL

Gabarit 5.05 m (two tracks + emergency)

Excavation Technique: conventional full face

Final lining: reinforced concrete (60-120 cm)

Length 1530 m

Maximum Depth 150 m

Distance between axis 37.5 m (about 3 diameters)

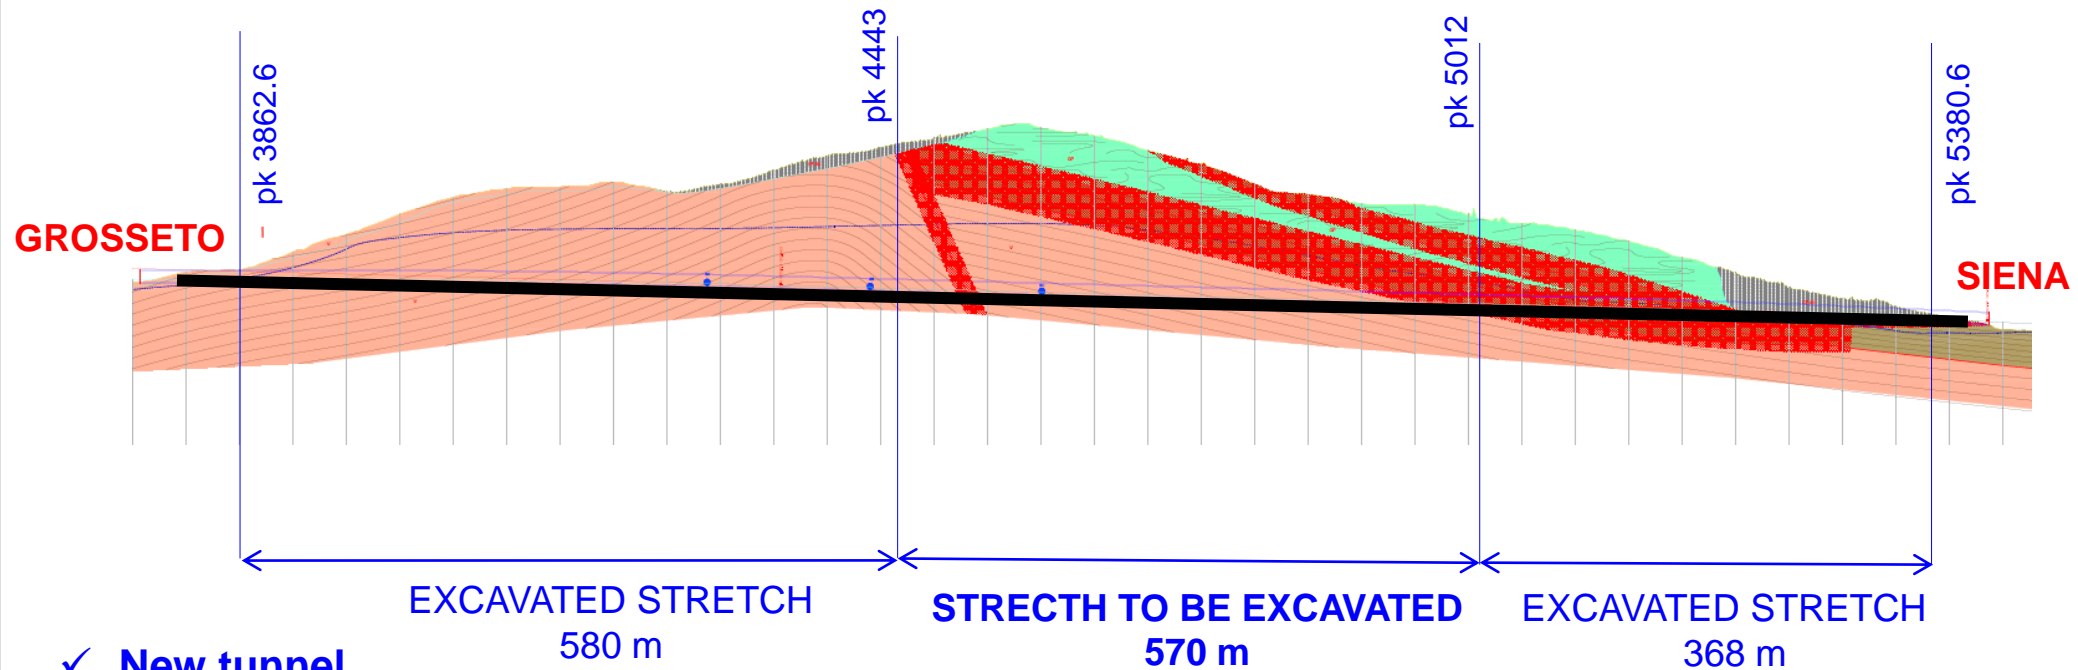
## ✓ New tunnel

- Instabilities at the face (front collapse at pk 5087)
- High values of convergence at pk 5045 - pk 5019 (6 – 21 cm)

## ✓ Existing tunnel

- Cracking and concrete detachment of the lining
- Uplift and deformation of the road platform

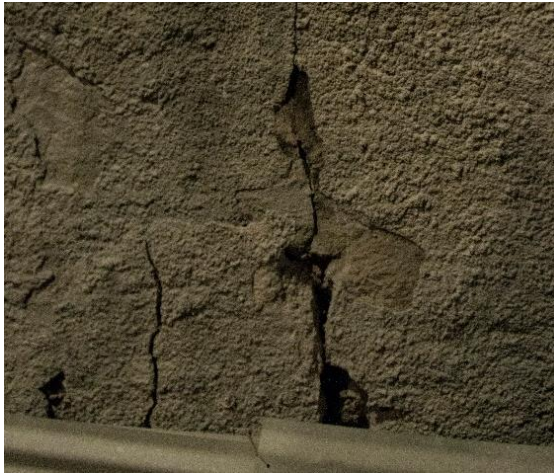
New cracks appearance

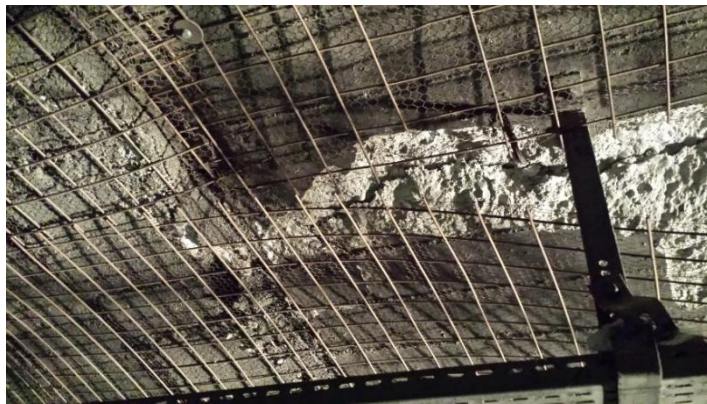
Vault concrete detachments

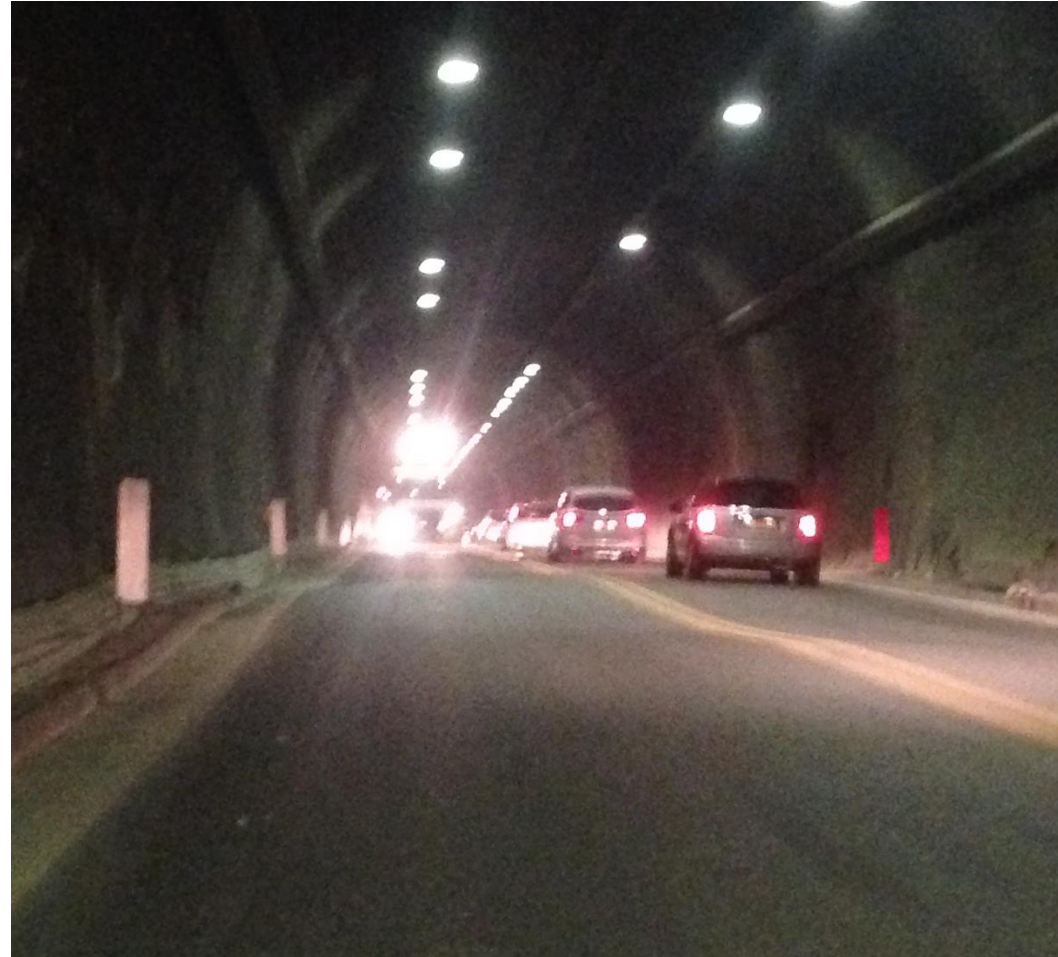
Uplift and deformation of the road platform

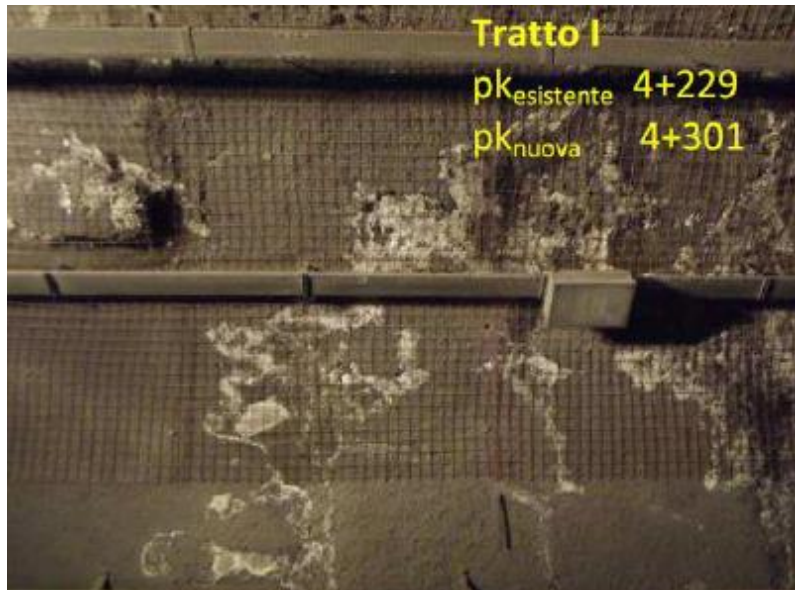
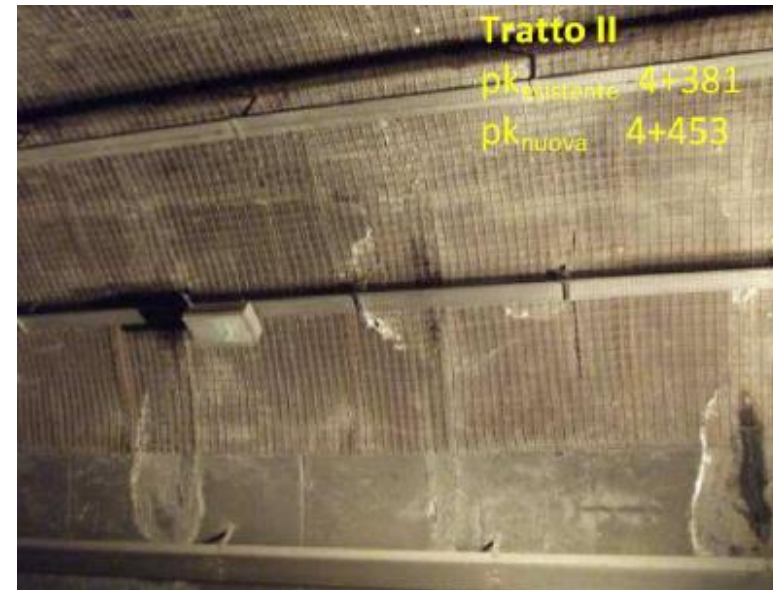
- ✓ Some detachments were also observed far away from the excavation faces of the new tunnel
- ✓ Phenomena probably associated to an earthquake of relatively low magnitude occurred in the area (end of **August 2015**)

- ✓ Old tunnel was closed (**August 2015**), traffic diverted to a secondary road
- ✓ Works for the construction of the new tunnel were suspend

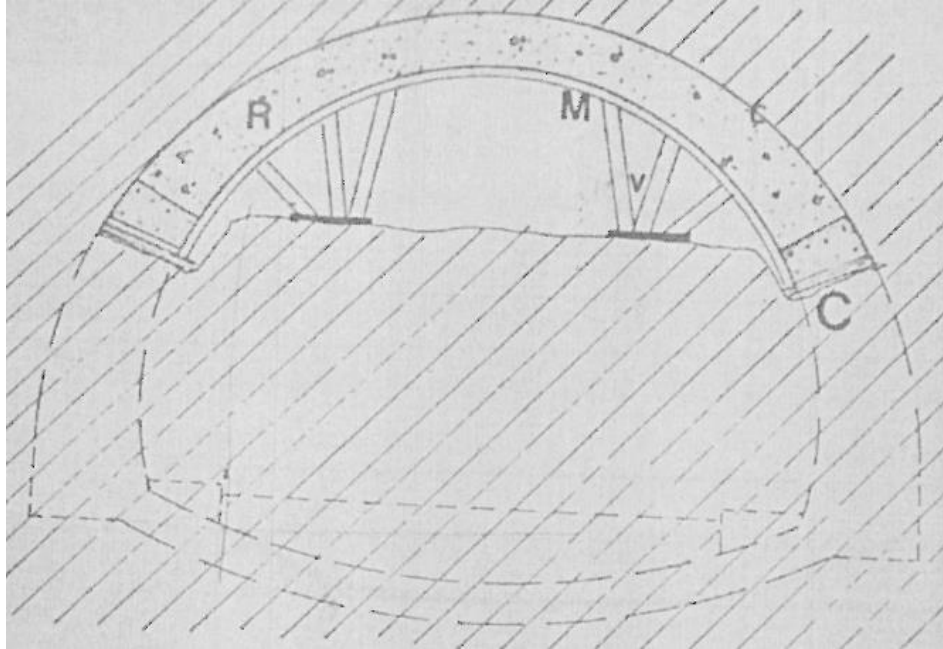
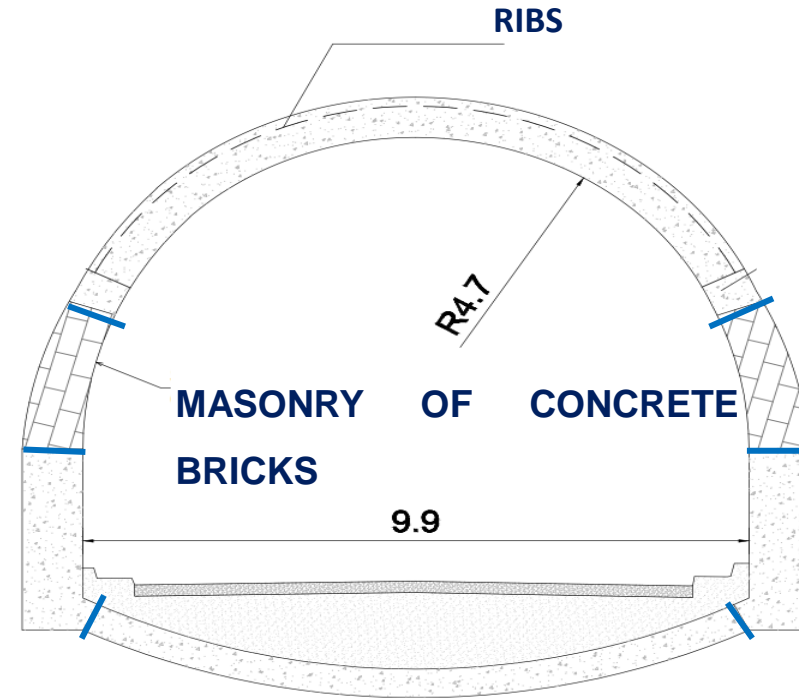
# Existing tunnel, historical information

- ✓ Construction years 60's – partialized face
- ✓ Preliminary support at the crown: metallic ribs
- ✓ Final lining: 6 cast in place independent segments (plane concrete and locally masonry)
- ✓ Thickness: crown/vault 0.5÷0.9 m – benches 0.7÷1.2 m – invert 0.5÷1.0 m

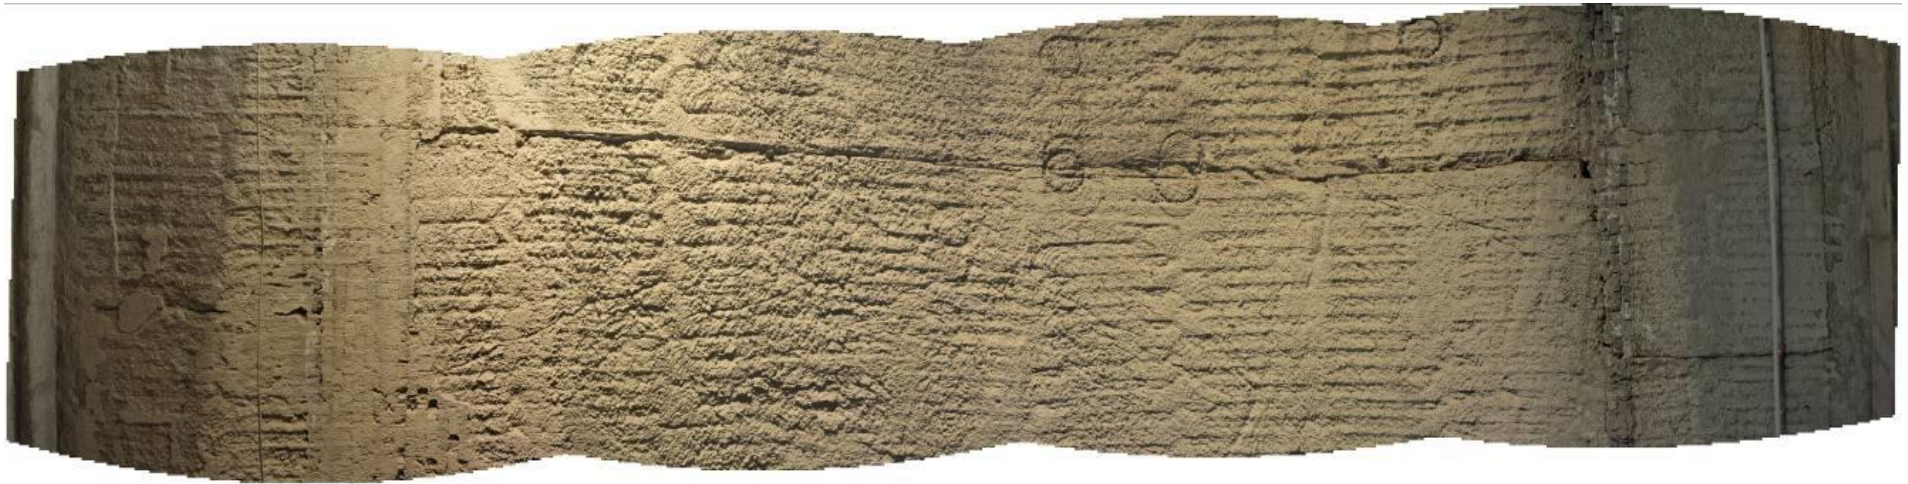
# Lining inspections and surveys

- ✓ Laser scanner reliefs (internal geometry)
- ✓ Visual and photographic reliefs (cracks), before and after hydro-demolition
- ✓ Continuous core bore-holes on the lining (lining thickness, concrete strength)
- ✓ Georadar surveys (lining thickness, ribs)
- ✓ Flat-Jack tests on concrete lining benches/springs (state of stress evaluation)

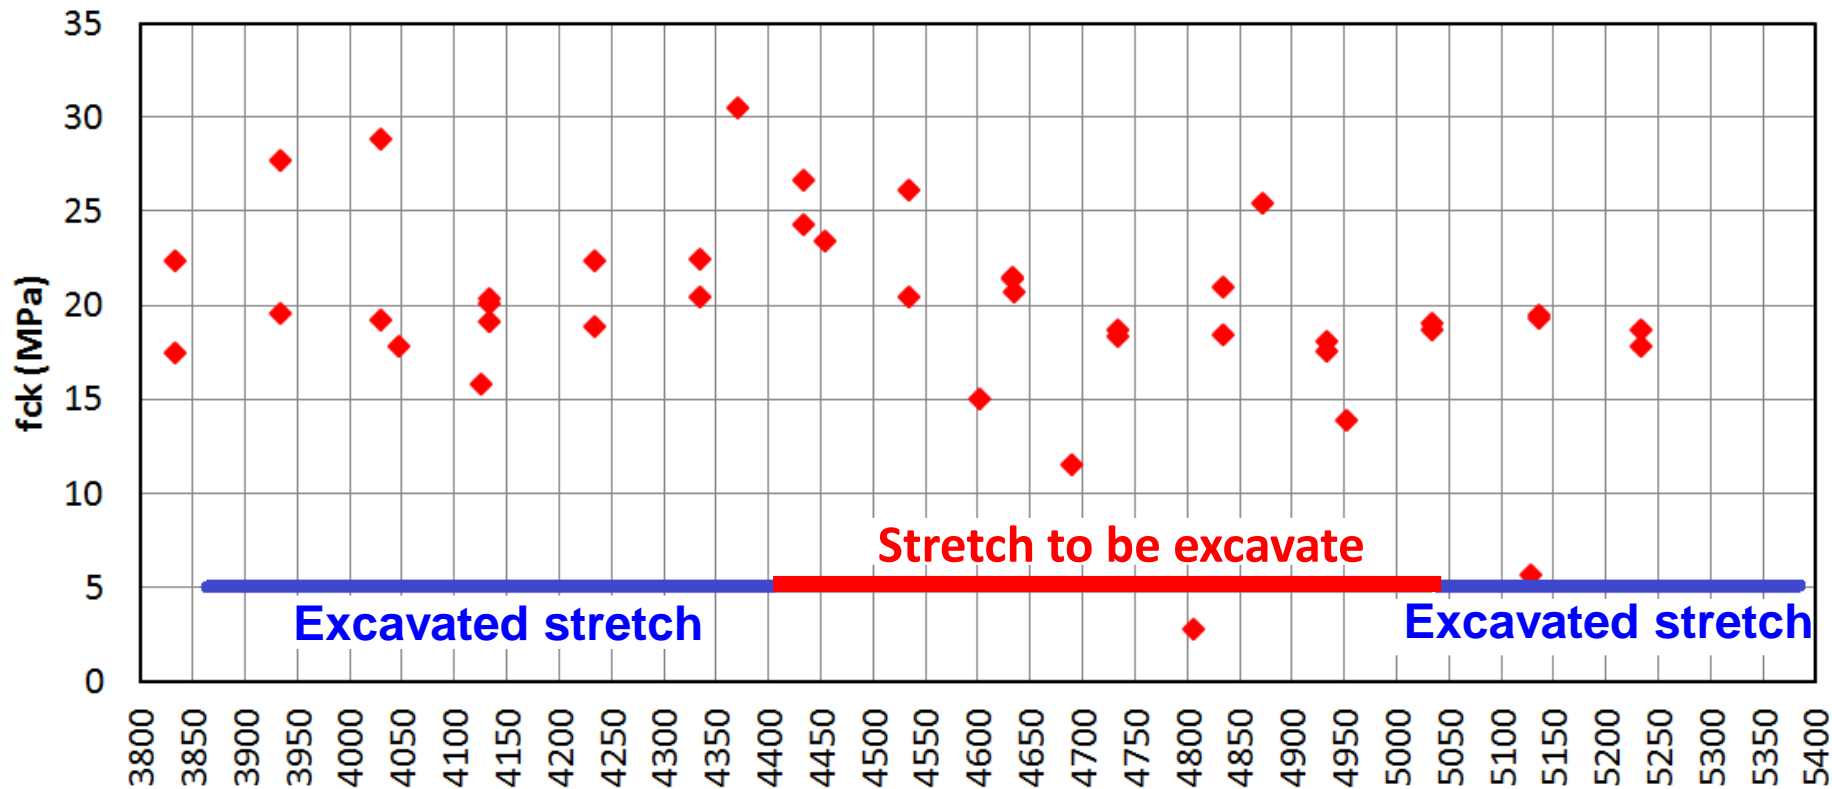
UCS results – Specimens of the lining (fck=15-25 MPa)

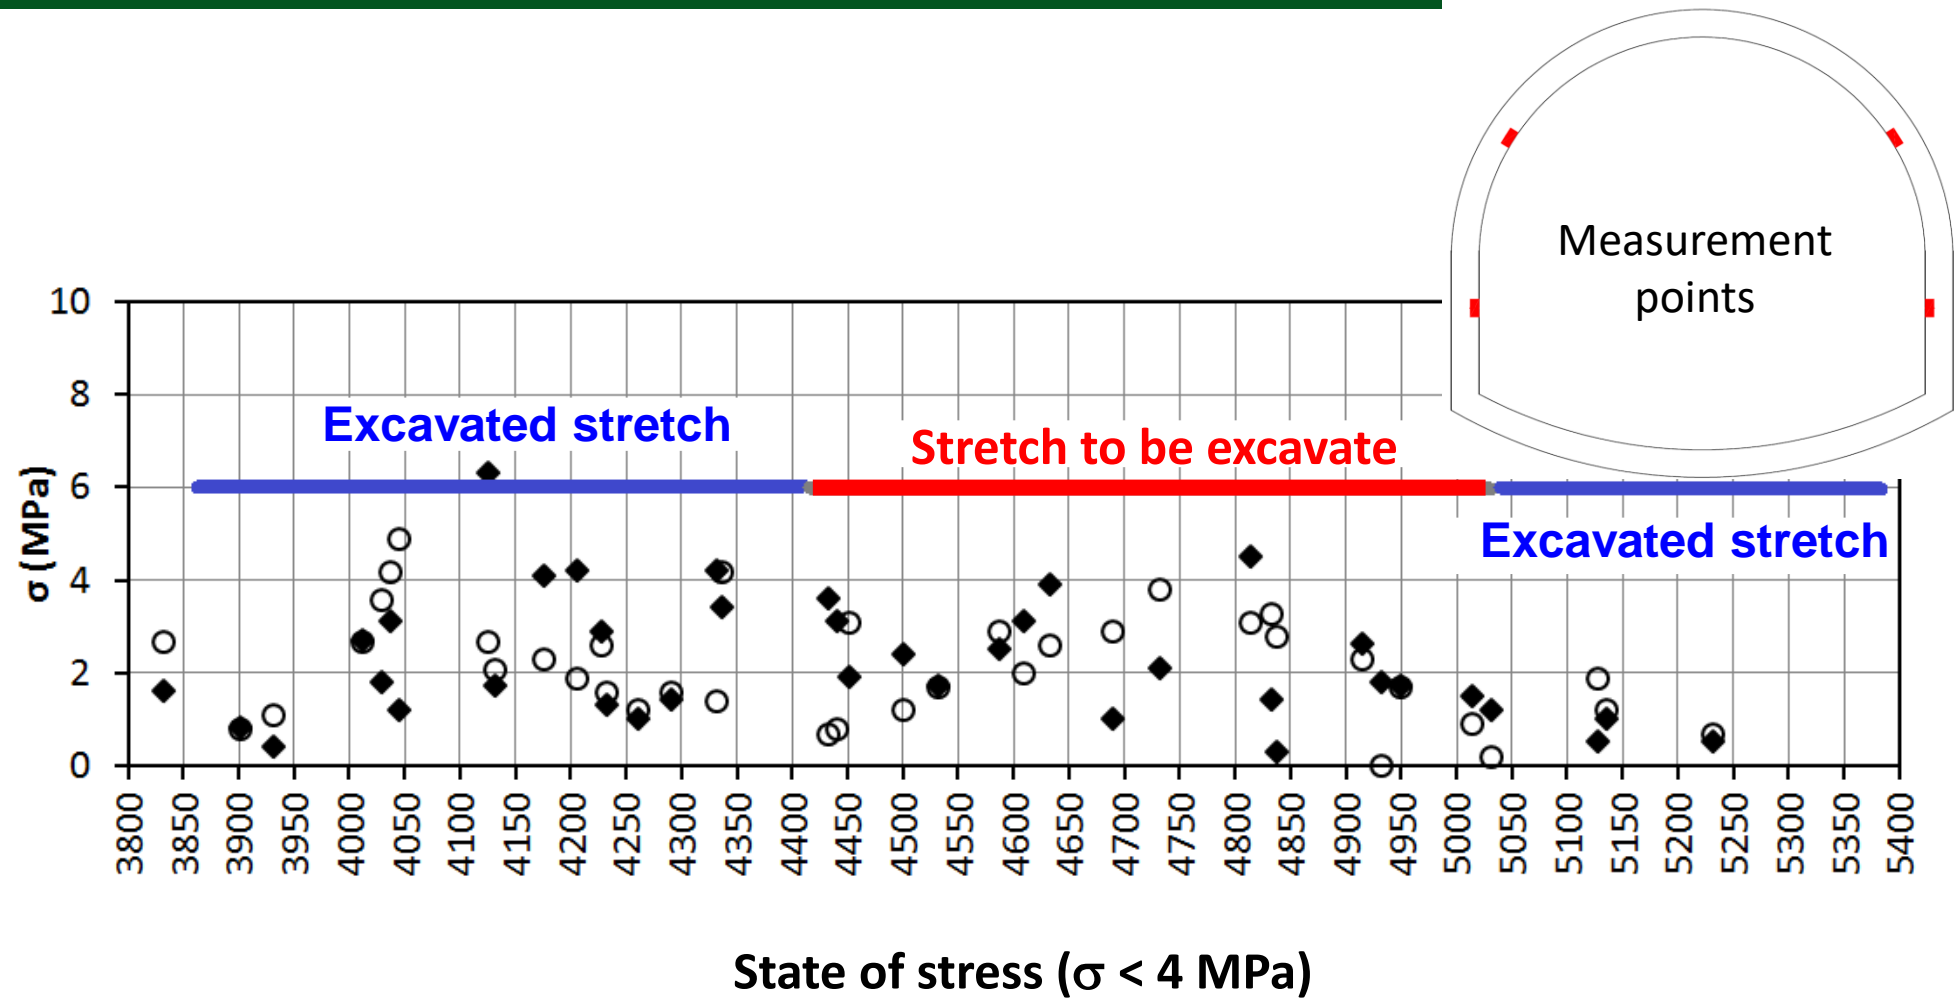
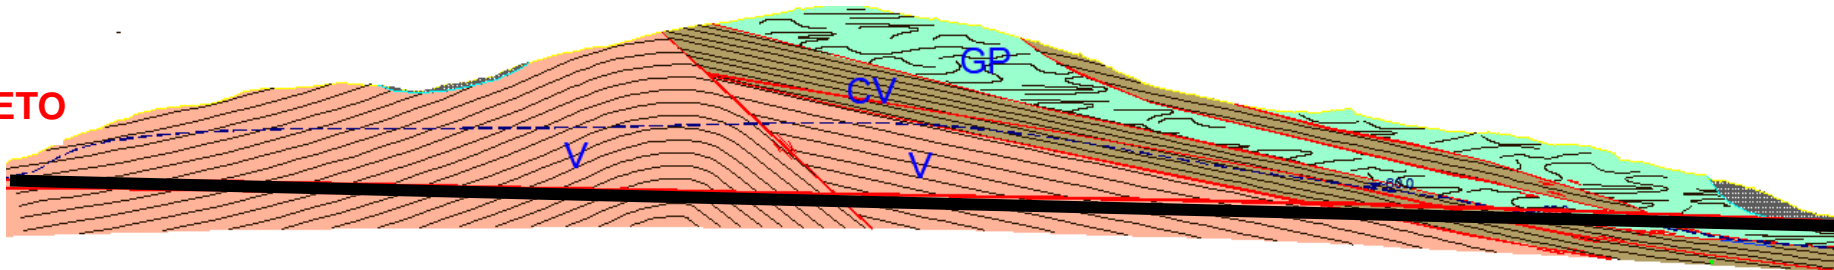
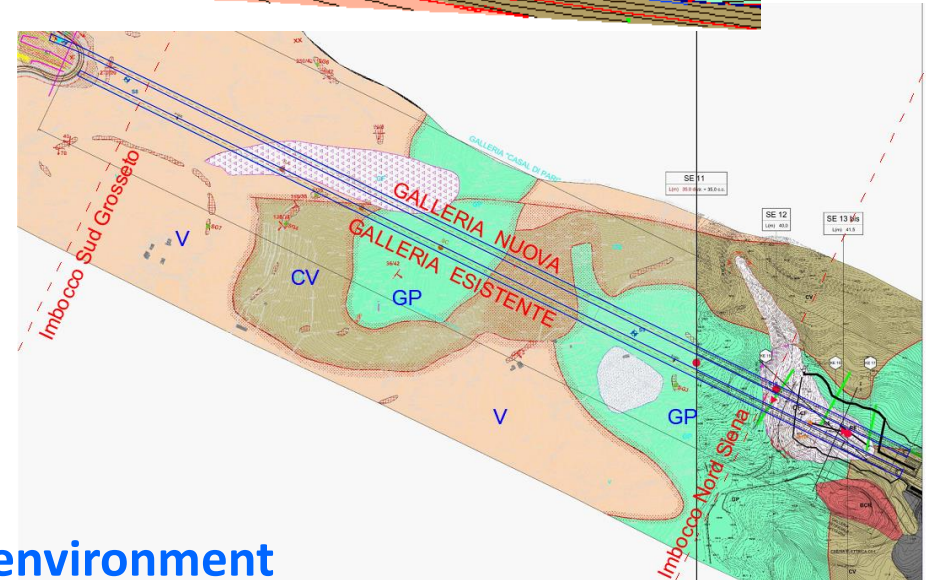
**Galestri e Palombini:** strata of clayey shales varicoloured (galestri) and siliceous/calcareous rocks (palombini)

**Calcare cavernoso:** calcareous and siliceous sands (very disturbed)

**Verrucano:** silty-sand shales with inter-bedded quartzarenitic and calcarenitic strata

**Very tectonically disturbed geo-environment**

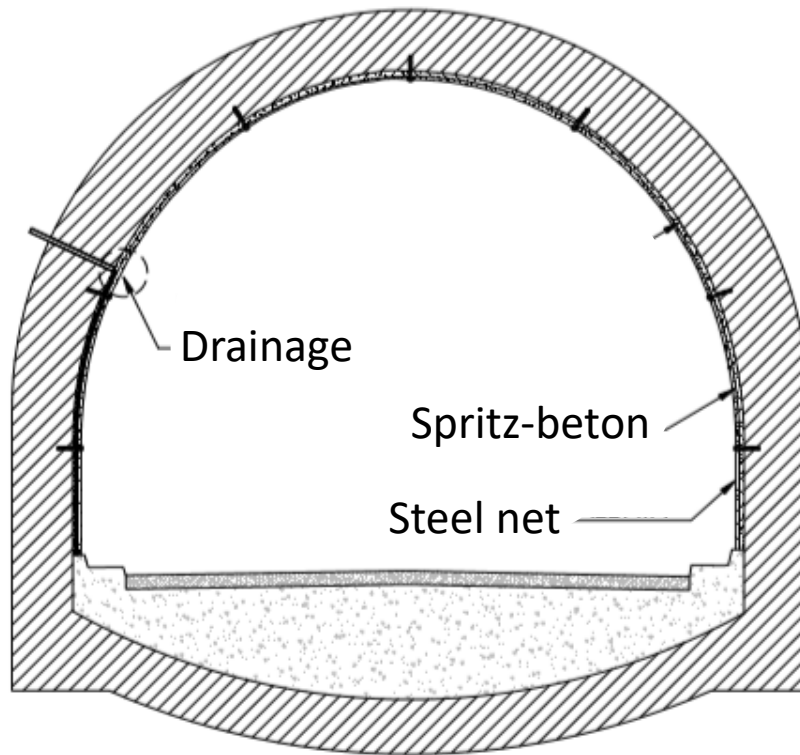
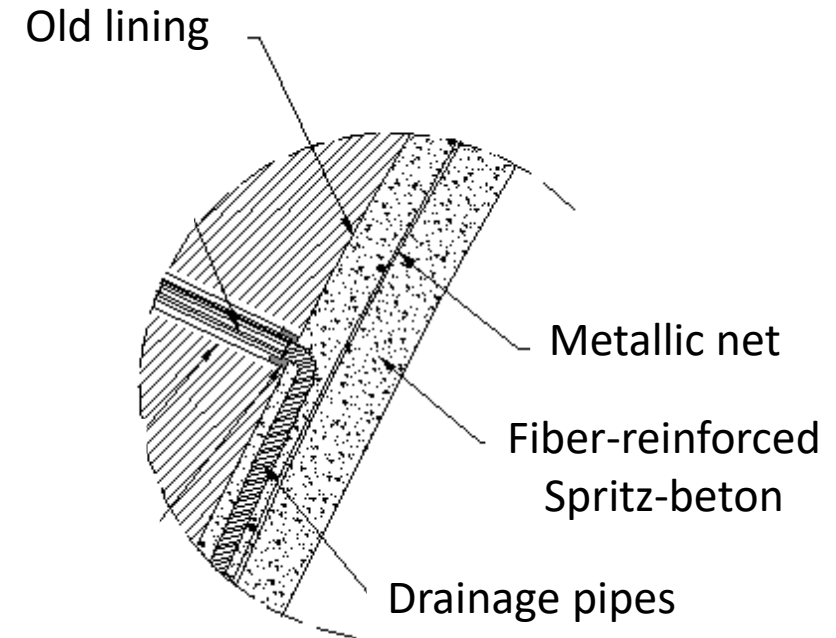
- ✓ “Section type A”, steel net  $\varnothing 6/20 \times 20$  + *spritz beton* fiber-reinforced - t=12 cm
- ✓ “Section type B”, steel net  $\varnothing 10/15 \times 15$  + *spritz beton* fiber-reinforced - t=20 cm

Local drainage pipes: surface dry during spritzing

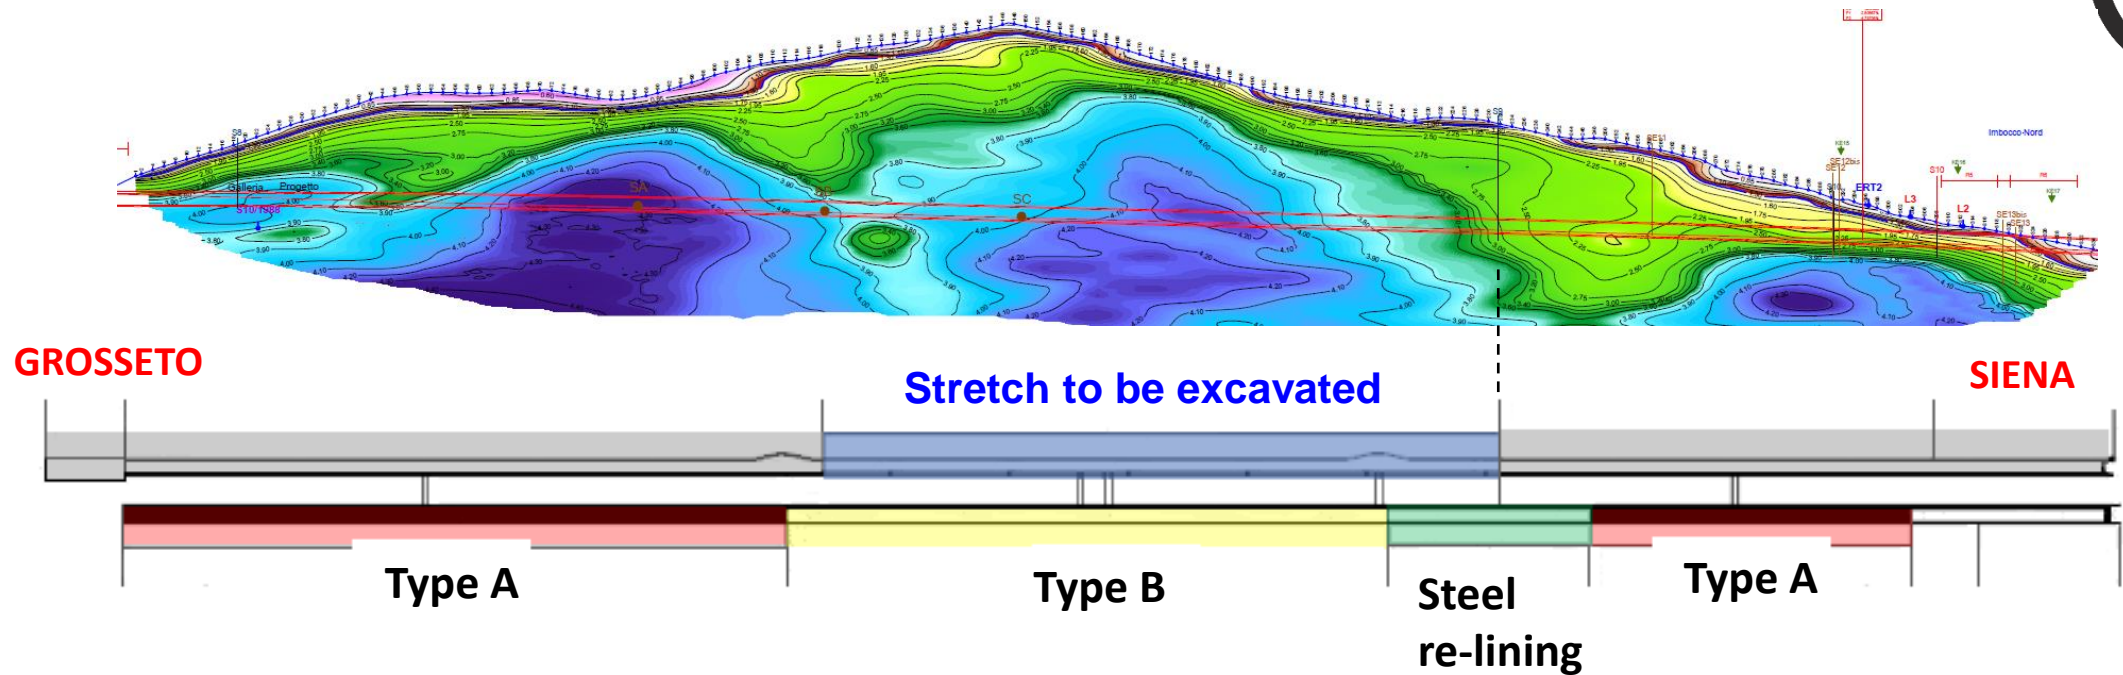
# Stretch of application of the selected sections

Section **type A** (light), stretch already excavated
-

Section **type B** (medium), stretch to be excavated but in presence of **good rocks**
-

**Full steel metallic re-lining**, corresponding to the stretch to be excavated with **poor soil/rock**

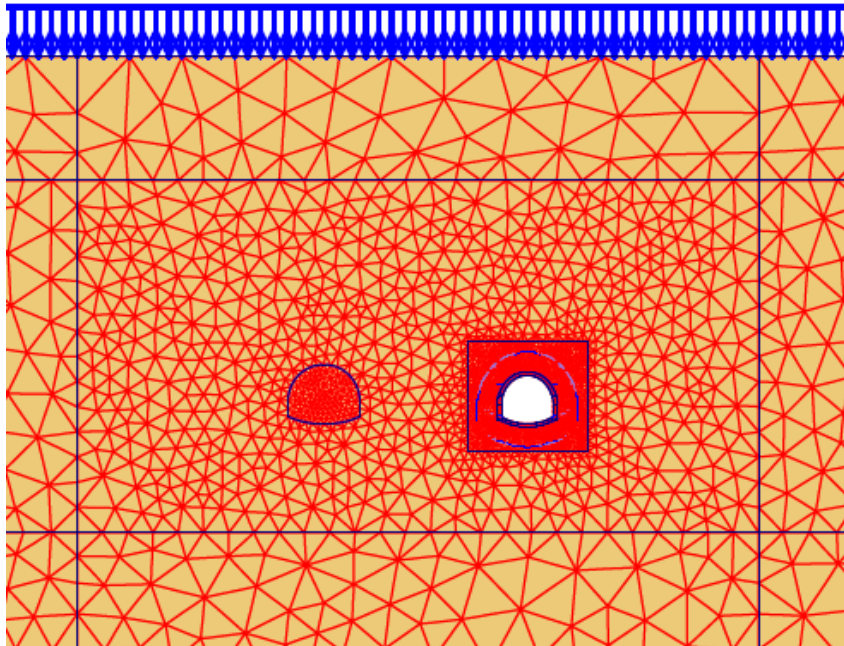
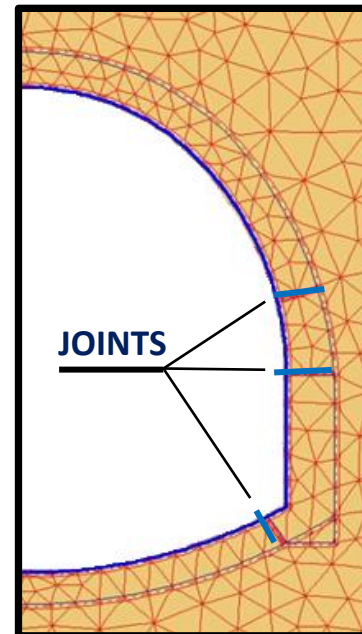
- ✓ Constitutive model: elastic perfectly plastic (for ground and lining)
- ✓ Mohr-Coulomb failure envelop
- ✓ Lining modelled by continuous elements (no tensile strength)
- ✓ Joints between lining segments simulated via purely frictional interfaces

$S_{\text{calotta}}$ (m)	$S_{\text{piedritti}}$ (m)	$S_{\text{AR}}$ (m)
0,7	1,0	0,6

$c'$ (kPa)	$\Phi'$ (°)	$E'$ (Mpa)
3000	28	26200

**Geometry and mechanical  
behaviour of the lining**

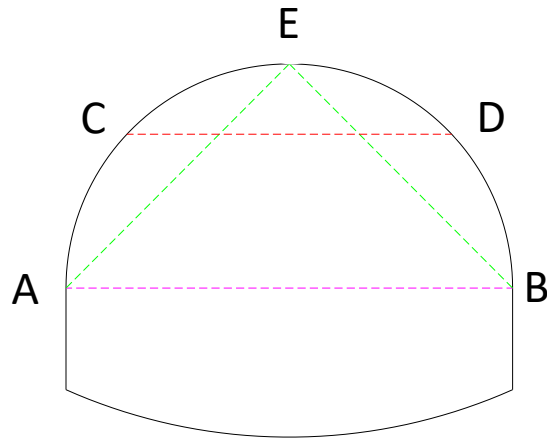
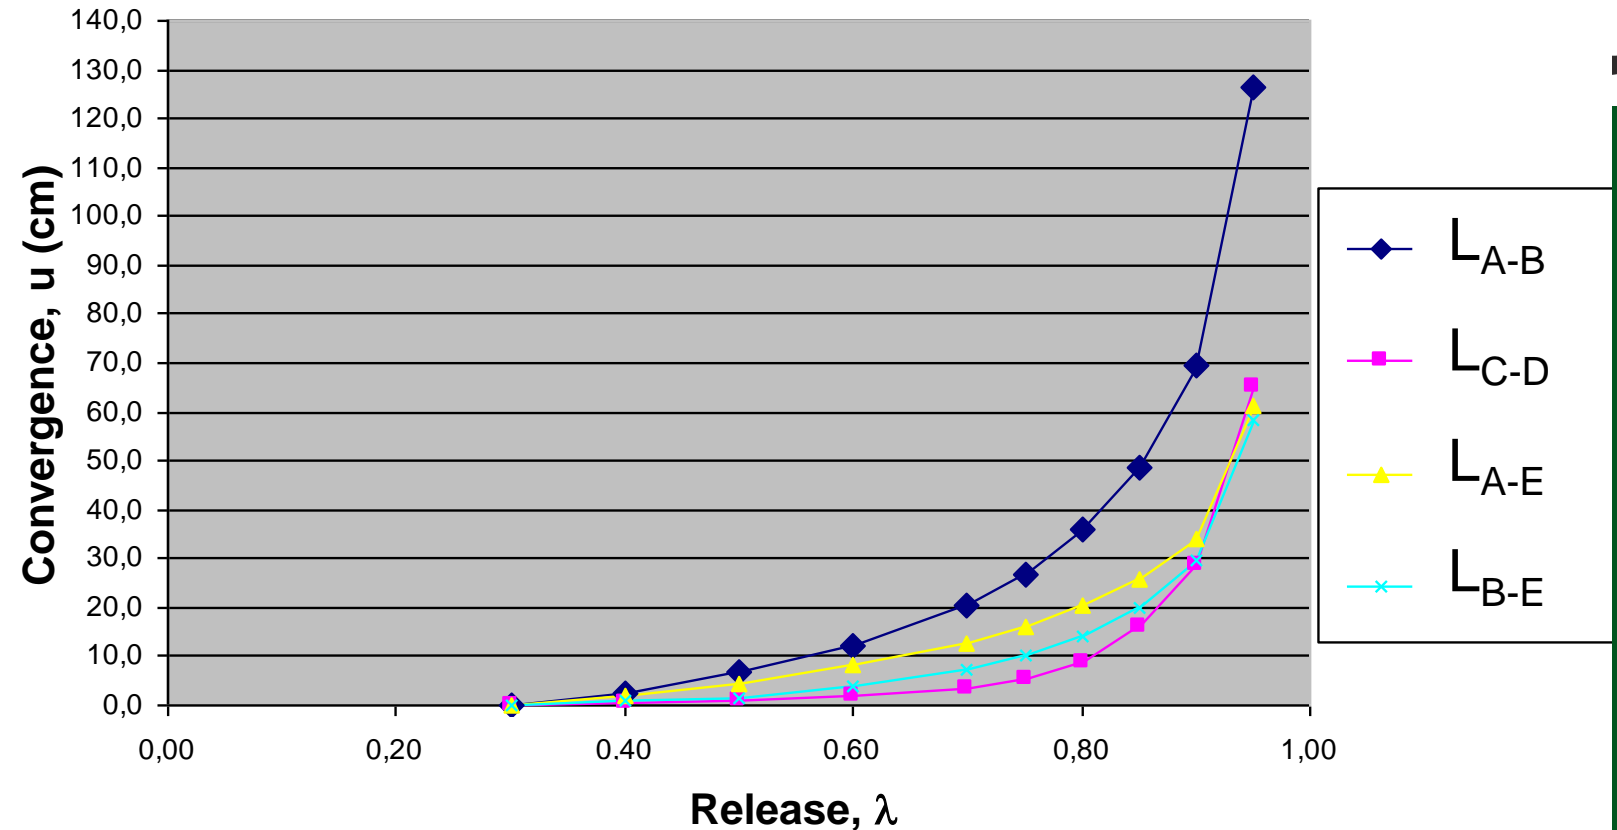
- ✓ Linear behaviour until value of  $\lambda = 0.6$
- ✓ Values of  $\lambda$  in the range 0.5-0.6 are assumed to be easily obtainable (consolidating adequately the nucleus and, eventually, realizing the invert close to the face)

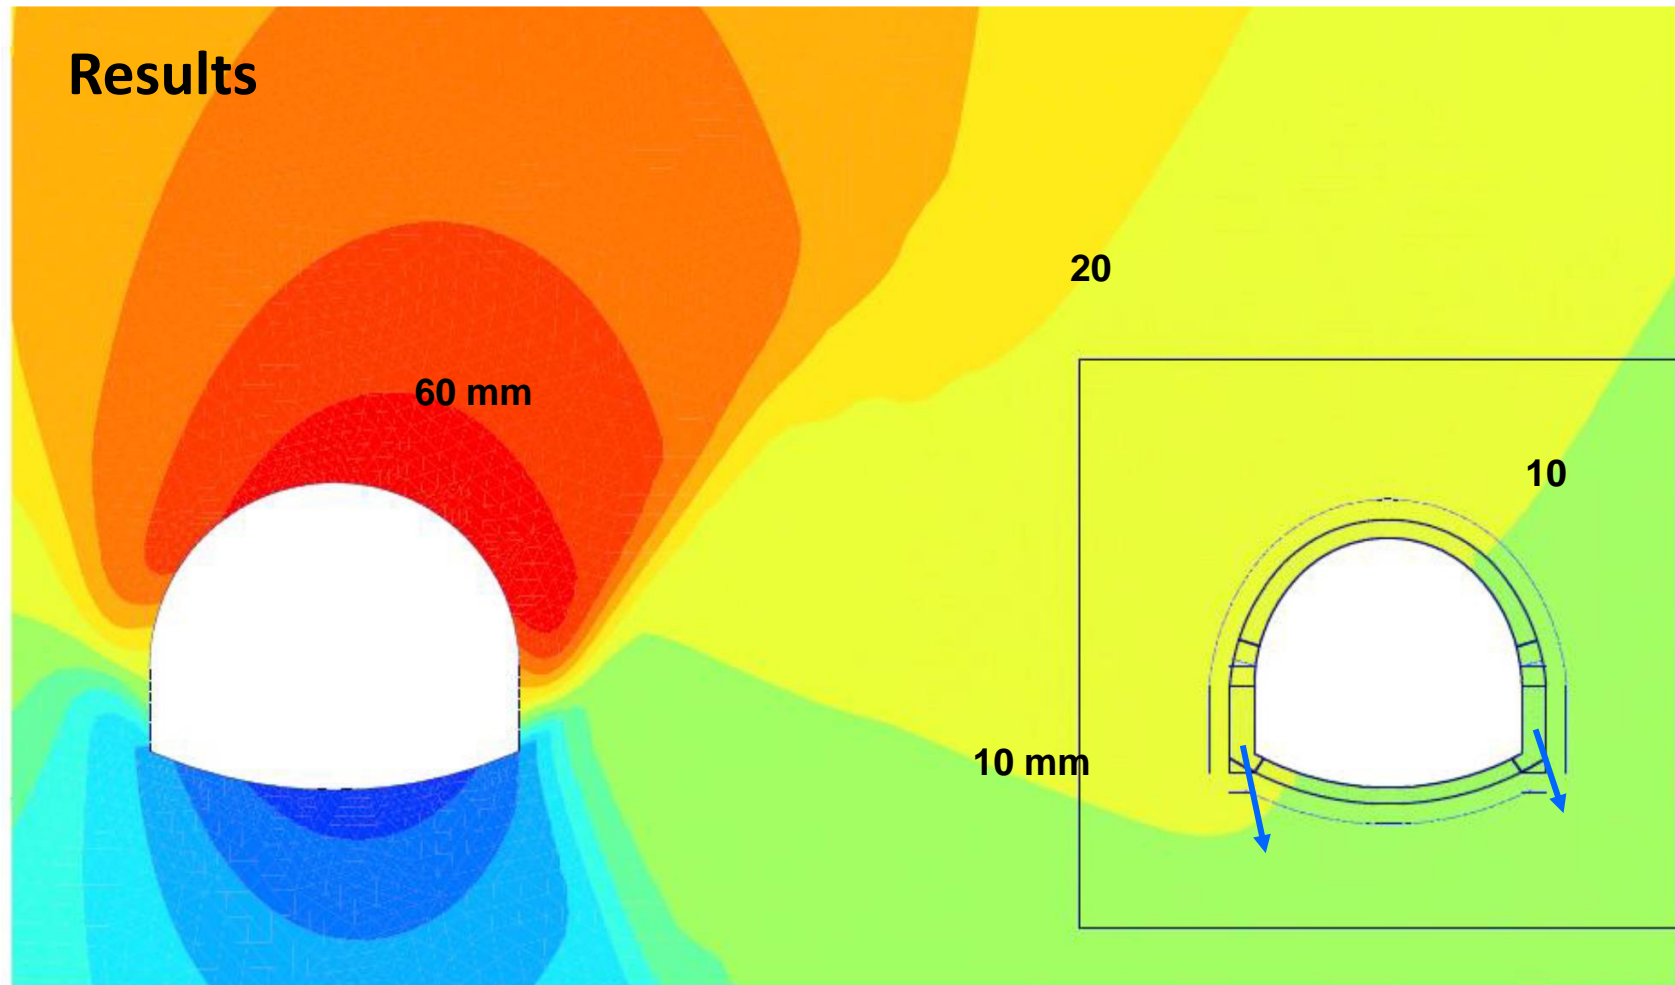
Vertical displacements induced by the excavation of the new tunnel ( $\lambda = 0.6$ )

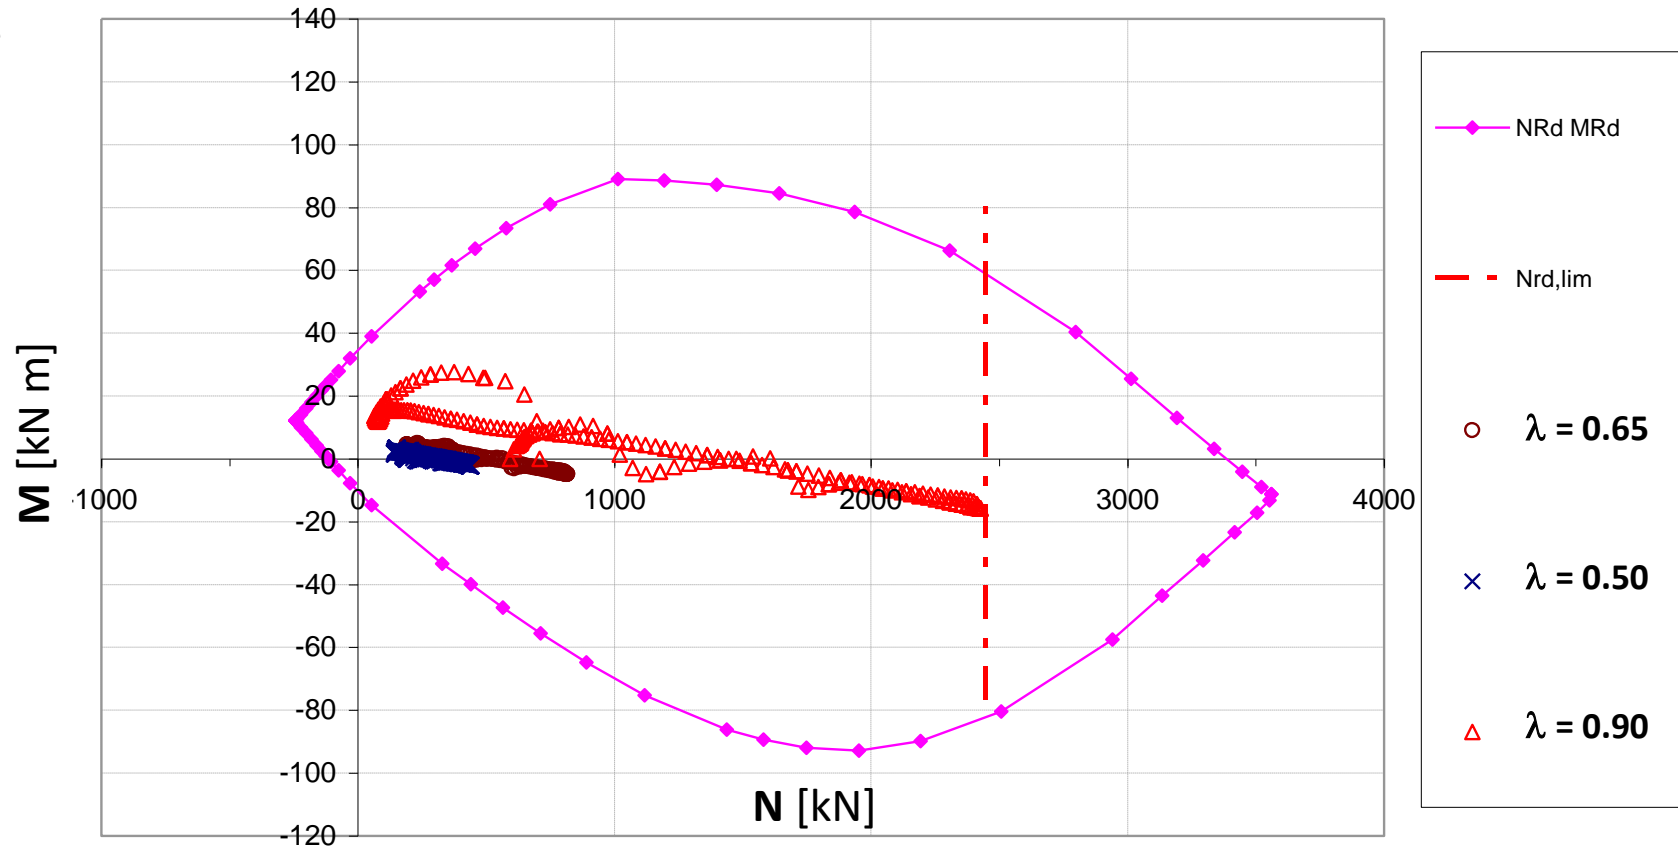
- ✓ The internal lining is structurally adequate until a value of  $\lambda = 0.65$
- ✓ For exceptional values of  $\lambda = 0.90$  (unrealistic), the internal lining is also verified

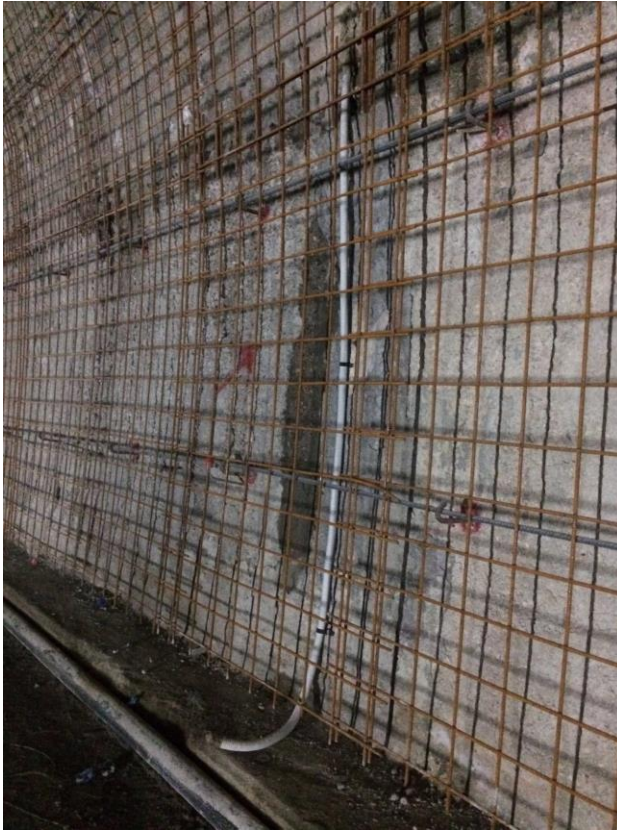
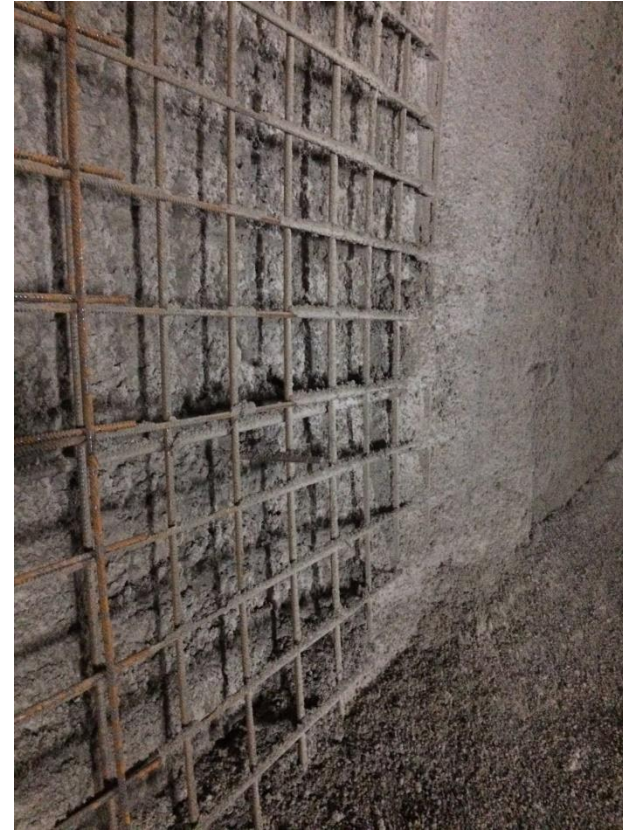
- ✓ Provisional works completed on **January 2016**
- ✓ Old road re-opened and works for the construction of new tunnel re-started on **February 2016**
- ✓ New tunnel completed on **April 2016 (9 months after the closure)**

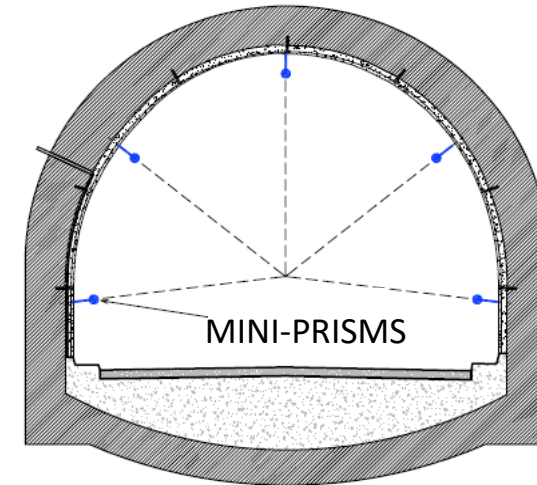
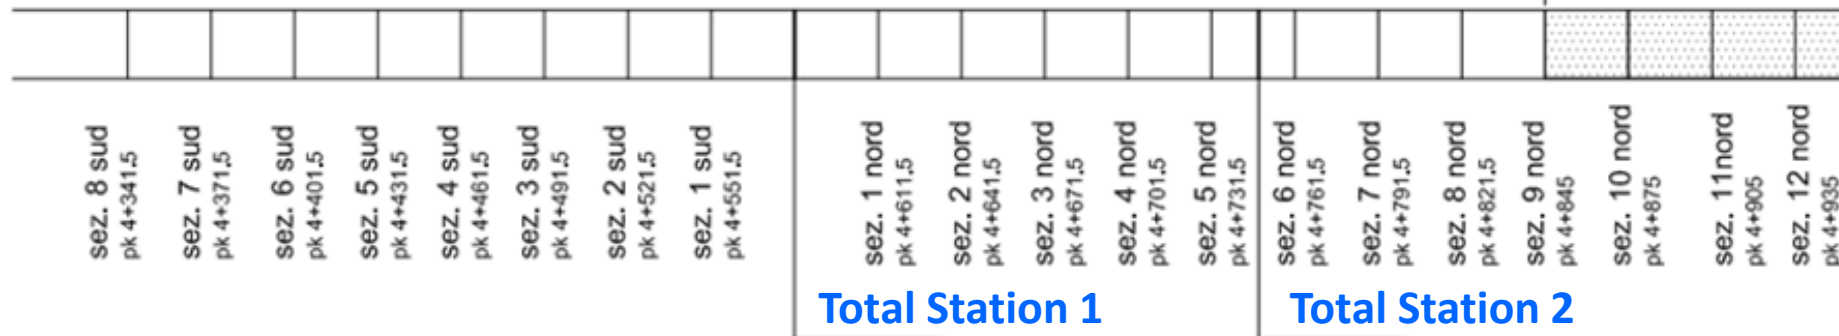
# Monitoring plan

- ✓ Displacements measurements (5 mini-prisms/20 sezioni)
- ✓ 2 automatic Total Station
- ✓ High measurements frequency (4 measures/day)
- ✓ Real time elaboration and data transmission

**Tunnel under construction**

**Old tunnel**
