*THE SECOND EUROPEAN CONFERENCE ON TUNNEL RENOVATION*

SIG SESSION: INSPECTION, INVESTIGATION AND  
MONITORING DURING SERVICE LIFE

**Damages on lining induced by the construction of a new tunnel  
and the design of refurbishment: a case history**

Motor way **E78 Grosseto-Siena** modernization works: construction of the new **Casal di Pari tunnel** close to the existing/old one

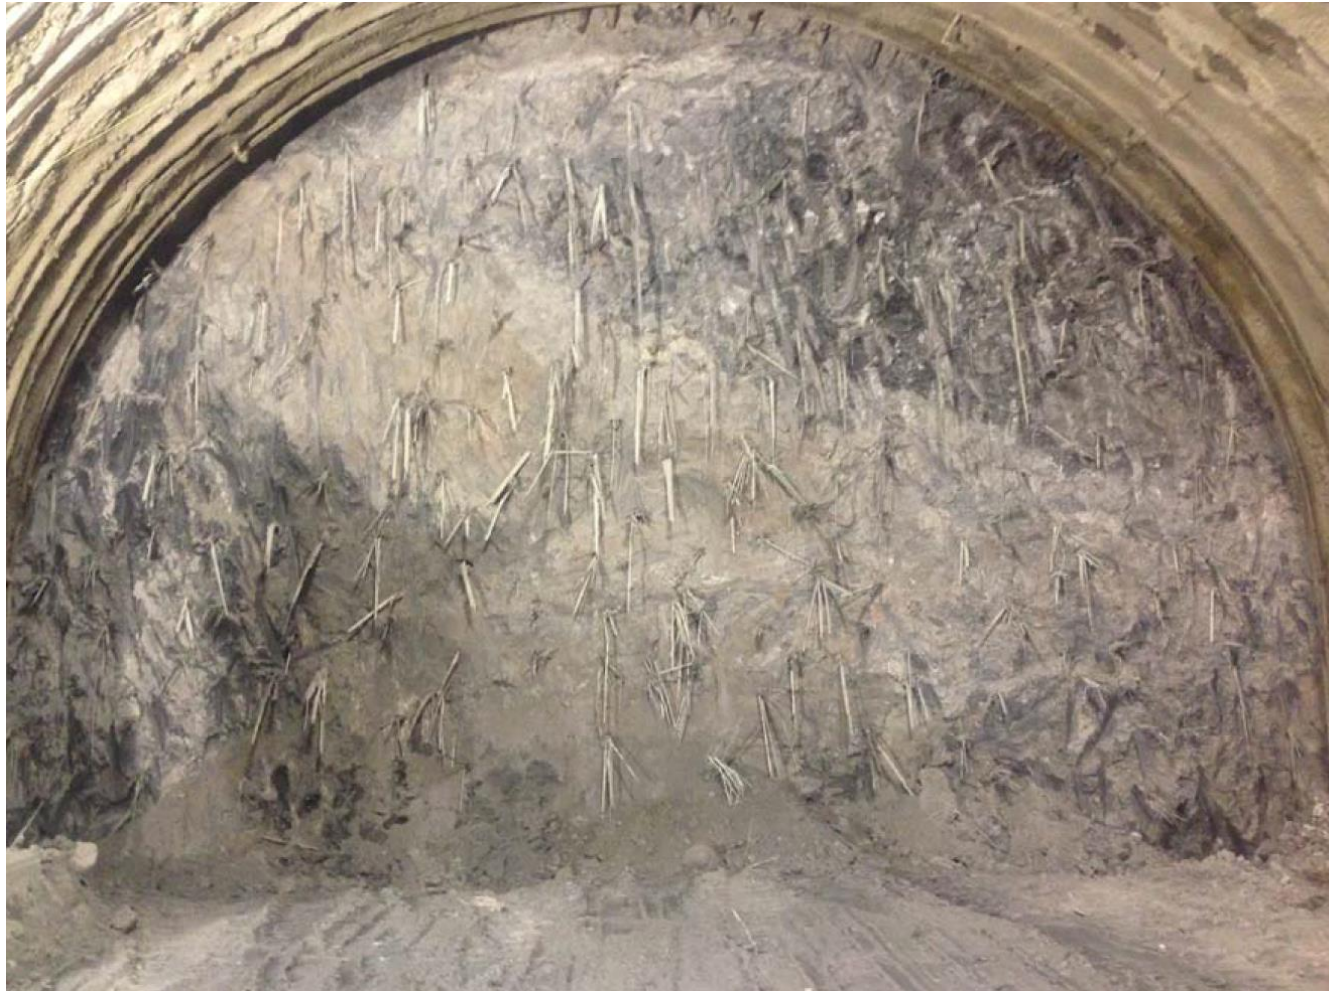
Siena side - face immediately after the excavation restart (formation: **GP/CV**)

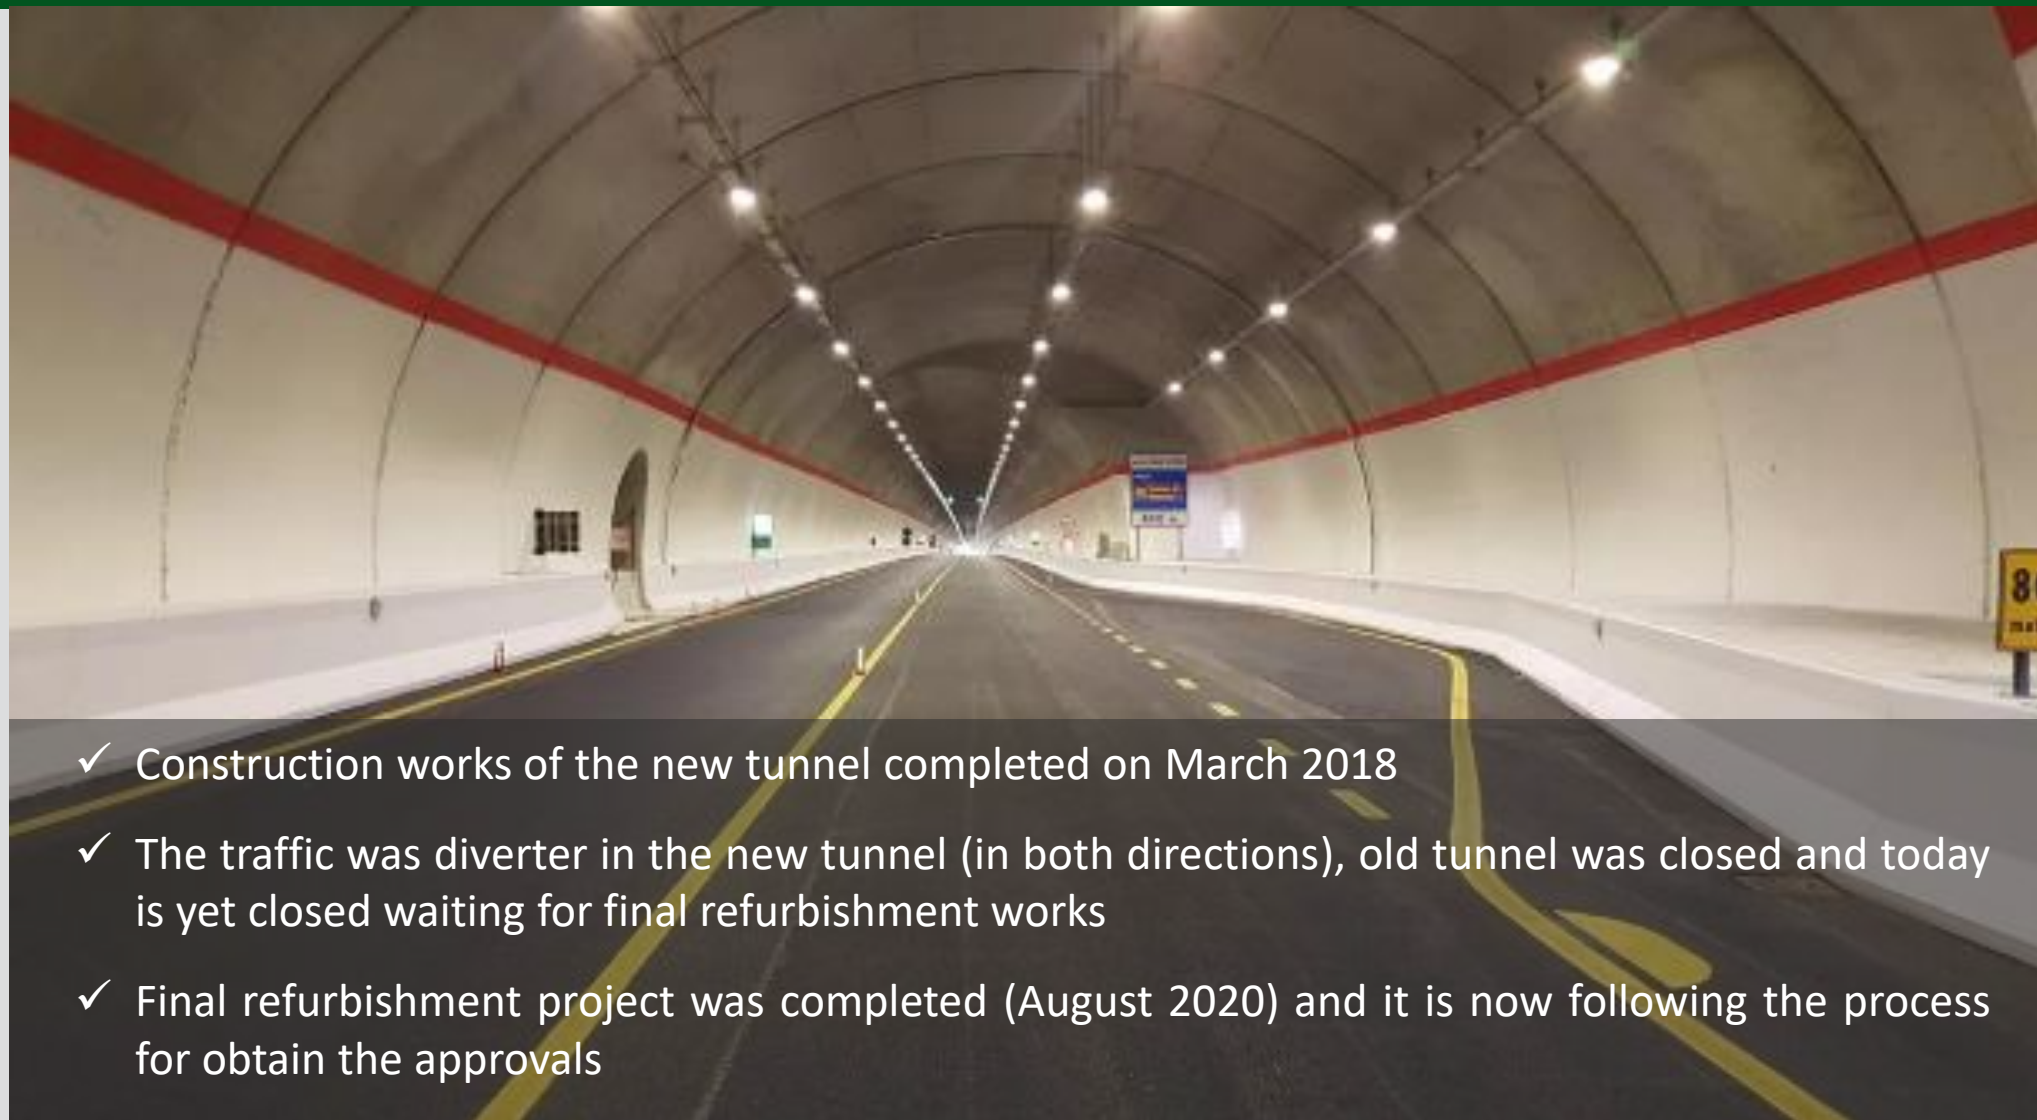
# Today/current situation

- ✓ Construction works of the new tunnel completed on March 2018
- ✓ The traffic was diverter in the new tunnel (in both directions), old tunnel was closed and today is yet closed waiting for final refurbishment works
- ✓ Final refurbishment project was completed (August 2020) and it is now following the process for obtain the approvals
